**PROGRAM FOR EXPERIMENTAL INVESTIGATION OF FAILURE
PROGNOSIS OF HELICOPTER GEARBOXES**

**Northrop Research and Technology Center
3401 West Broadway
Hawthorne, Calif. 90250**

August 1976

Final Report

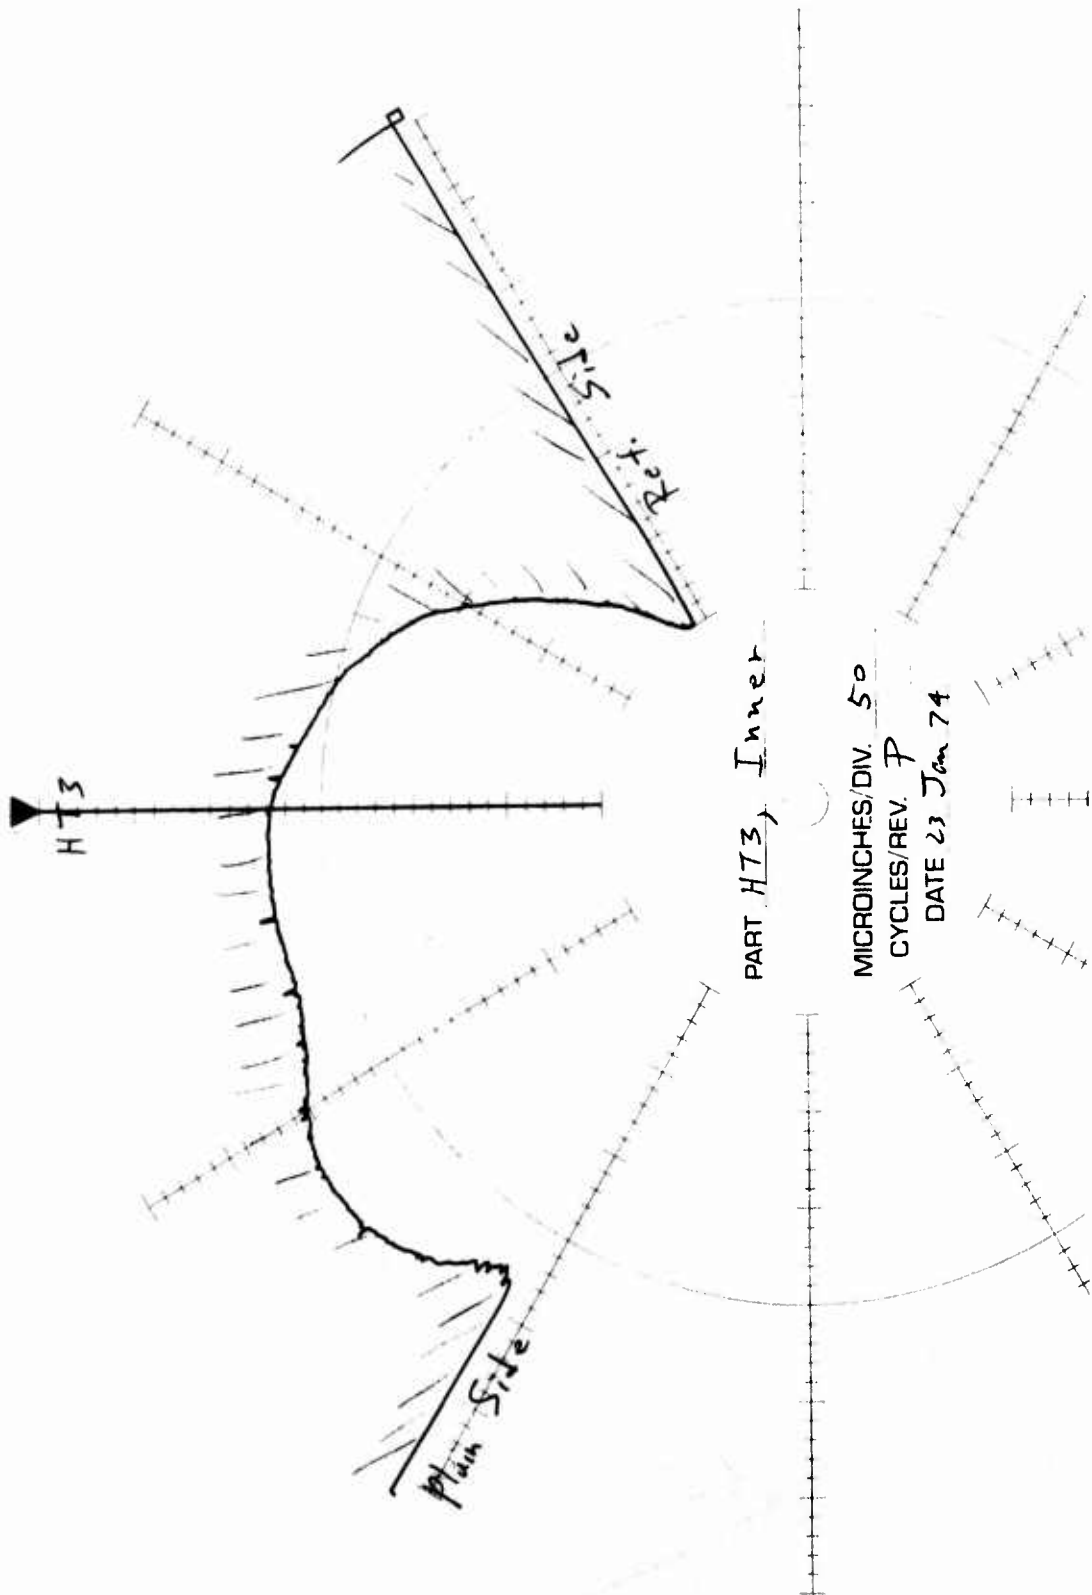
Figure 99. HT-3 Cross-Groove Profile at 877 Test Hours.

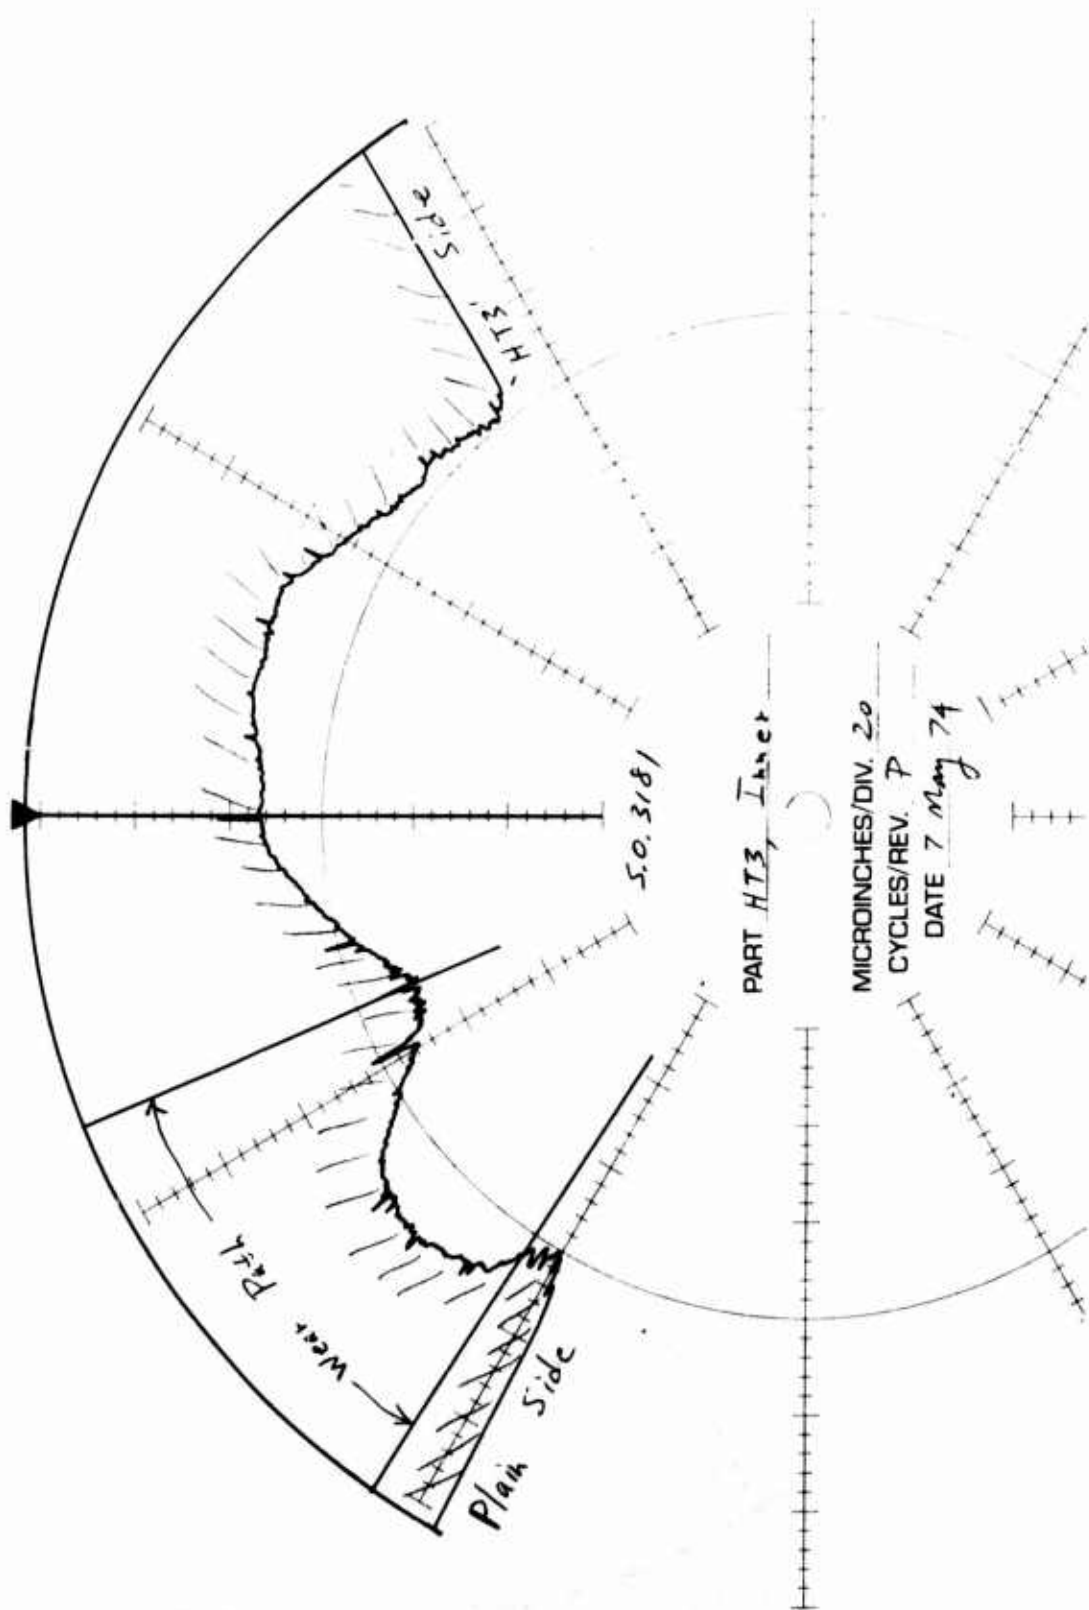
Figure 100. HT-3 Cross-Groove Profile at 1454 Test Hours.

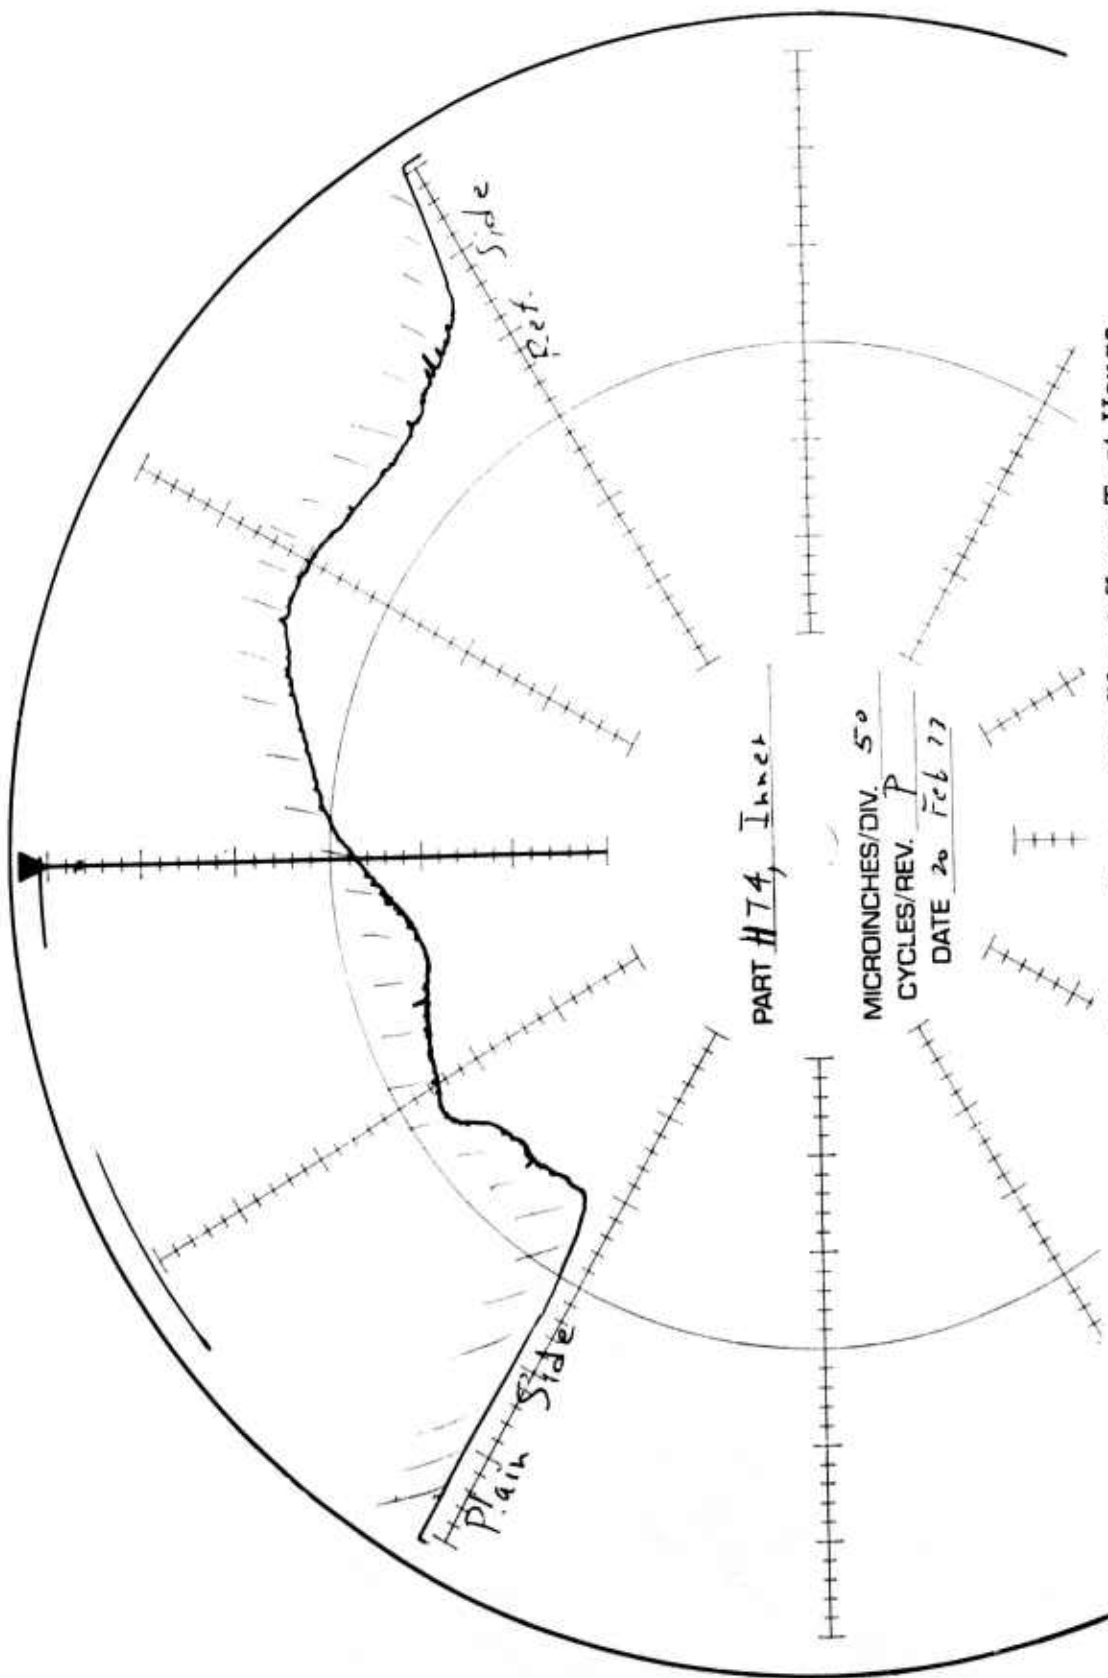
Figure 101. HT-4 Cross-Groove Profile at Zero Test Hours.

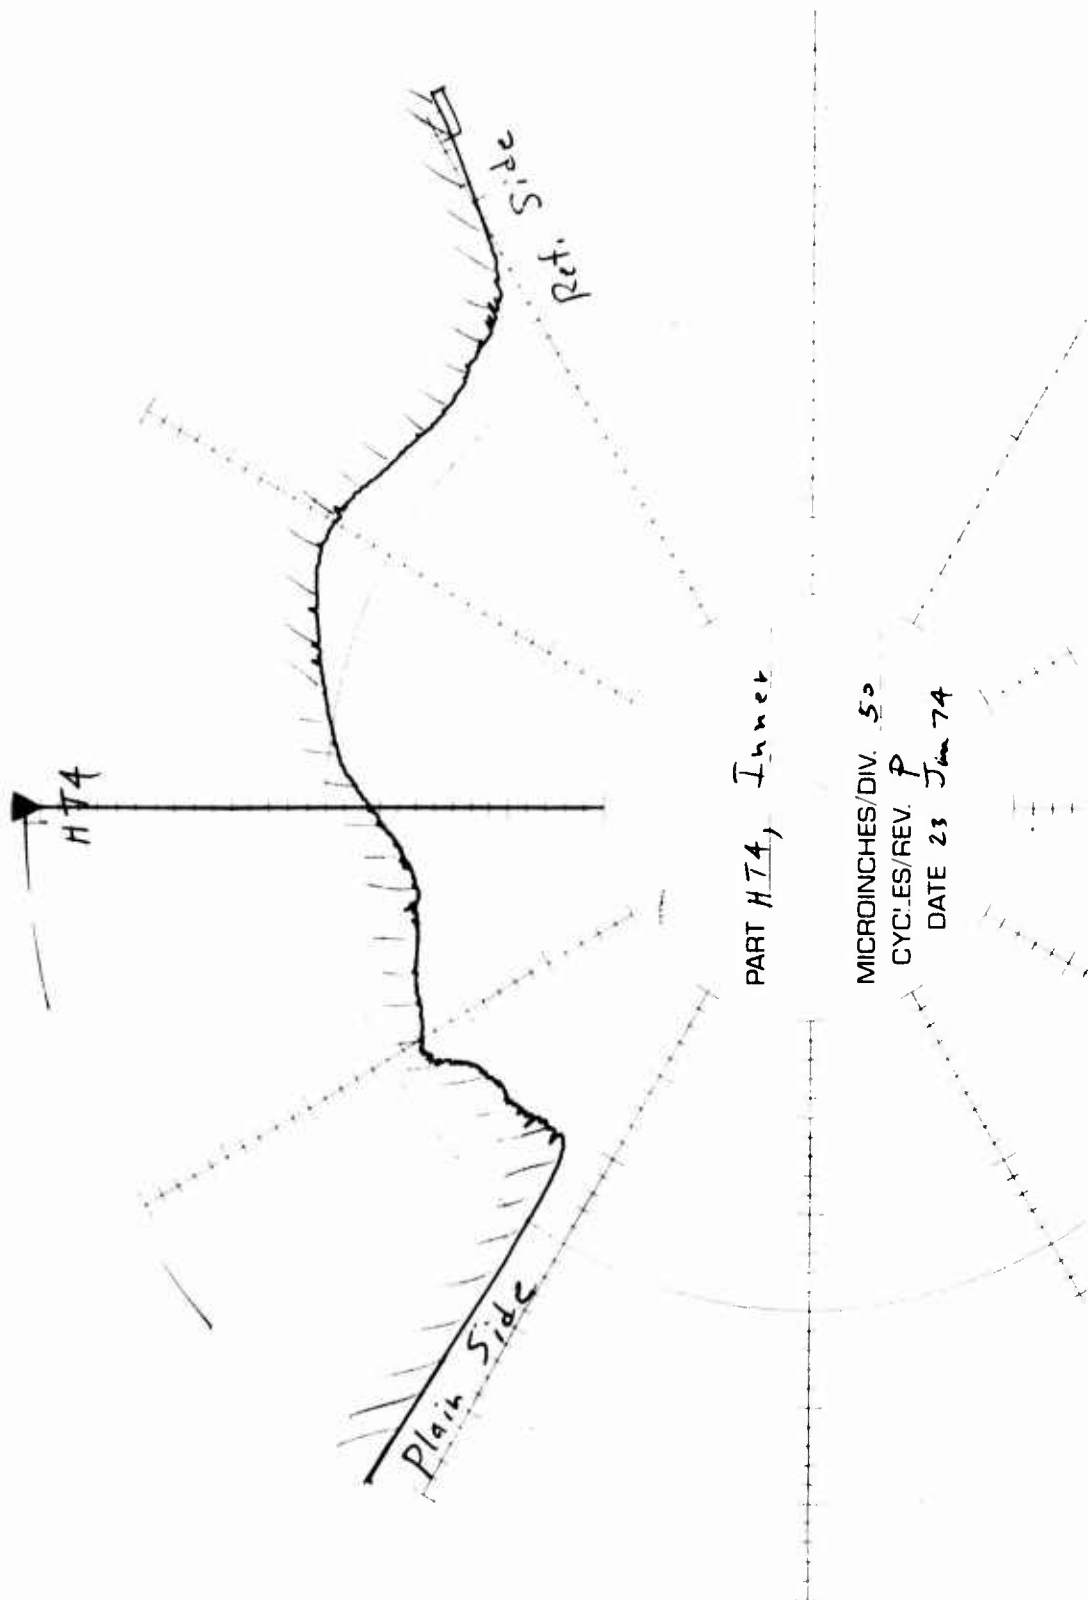
Figure 102. HT-4 Cross-Groove Profile at 877 Test Hours.

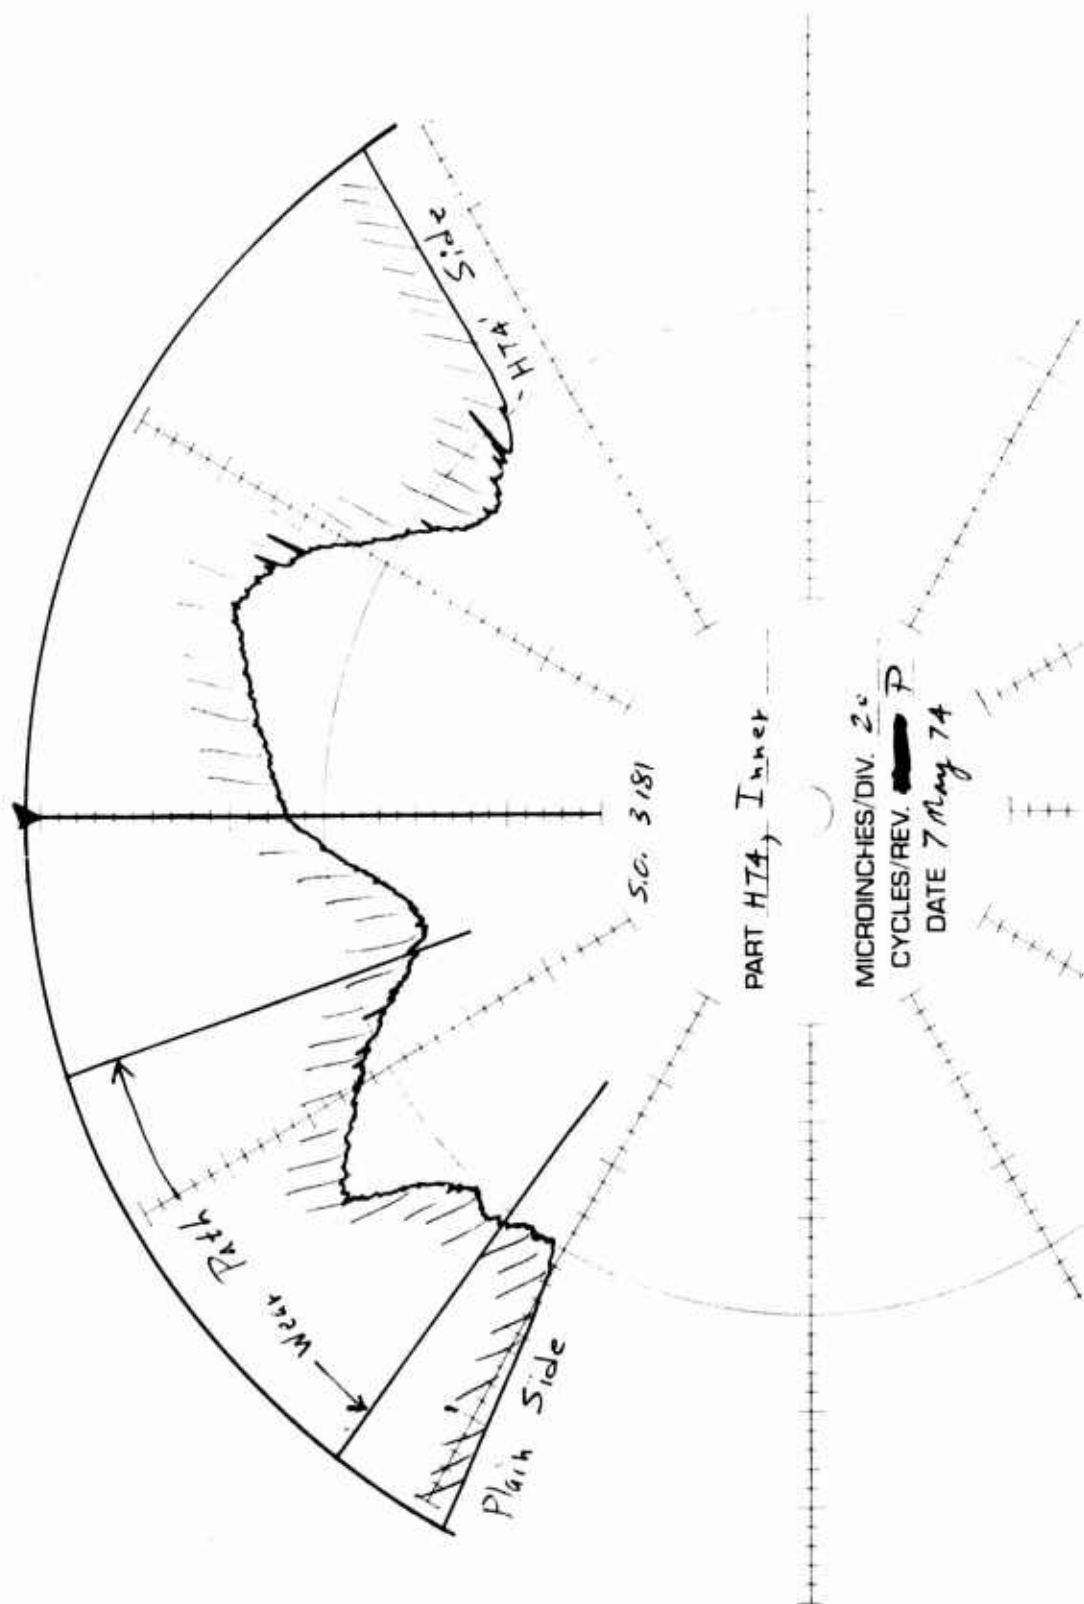
Figure 103. Cross-Groove Profile at 1454 Test Hours.

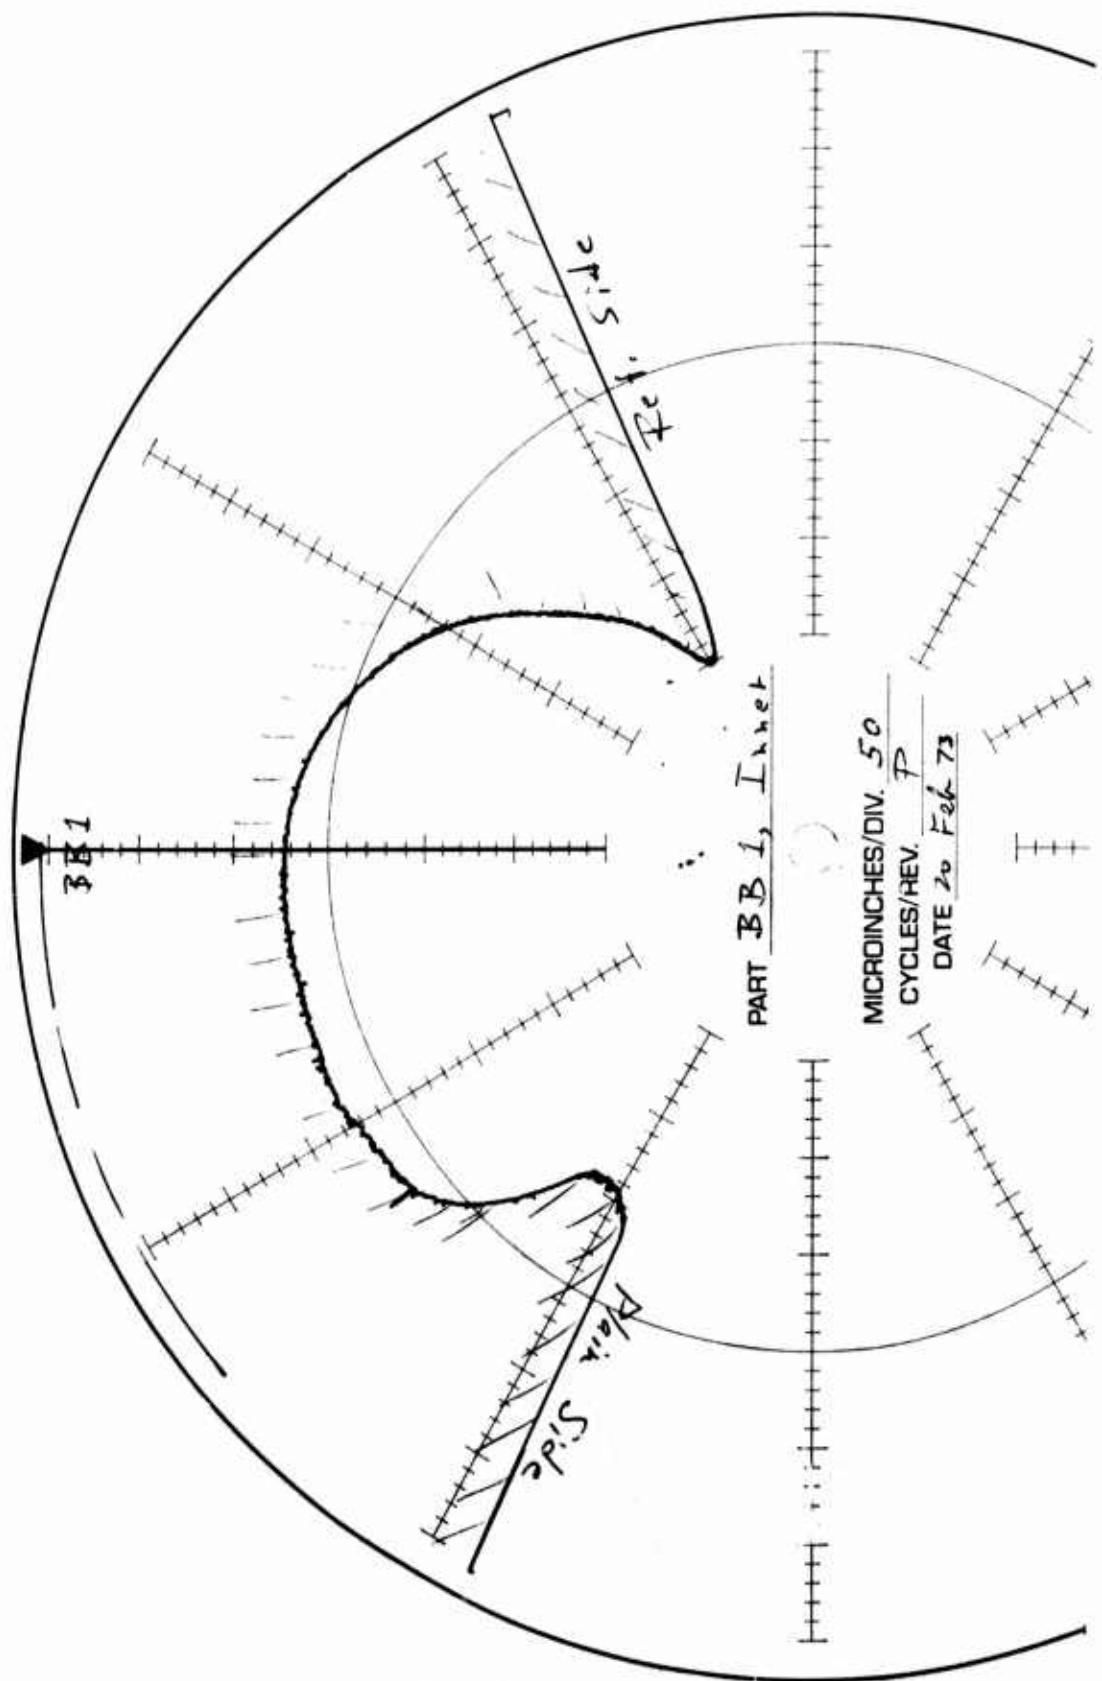
Figure i14. BB-1 Cross-Groove Profile at Zero Test Hours.

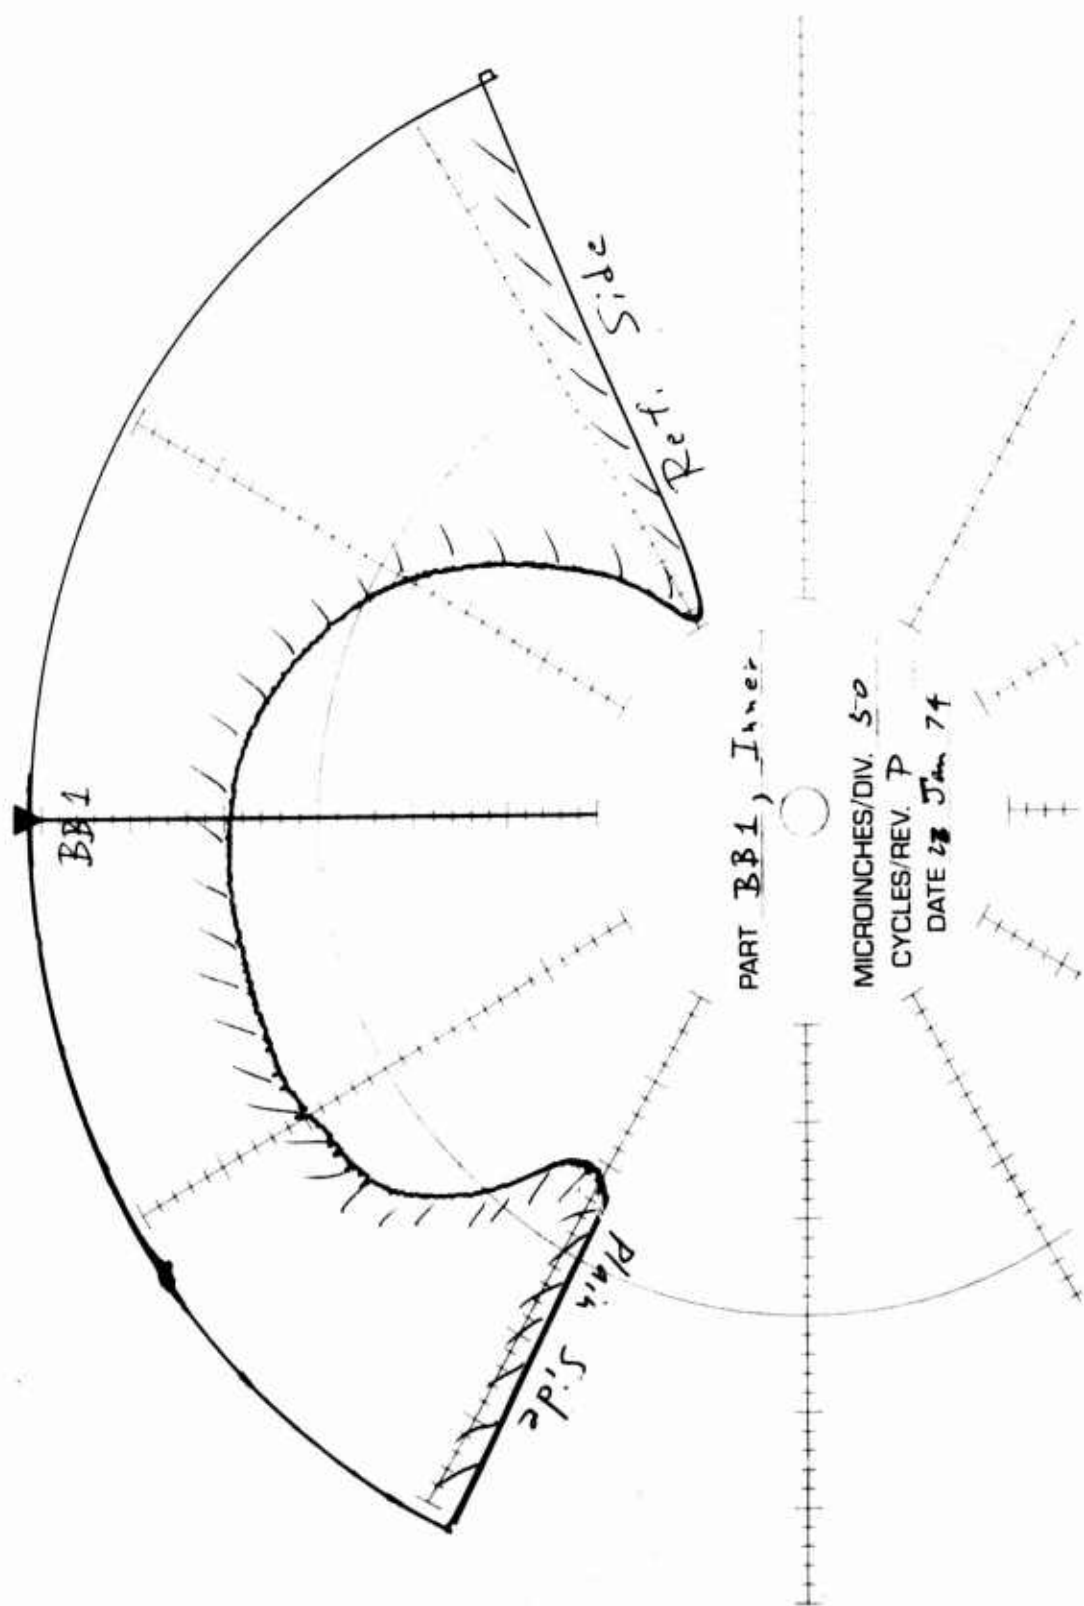
Figure 115. BB-1 Cross-Groove Profile at 166 Test Hours.

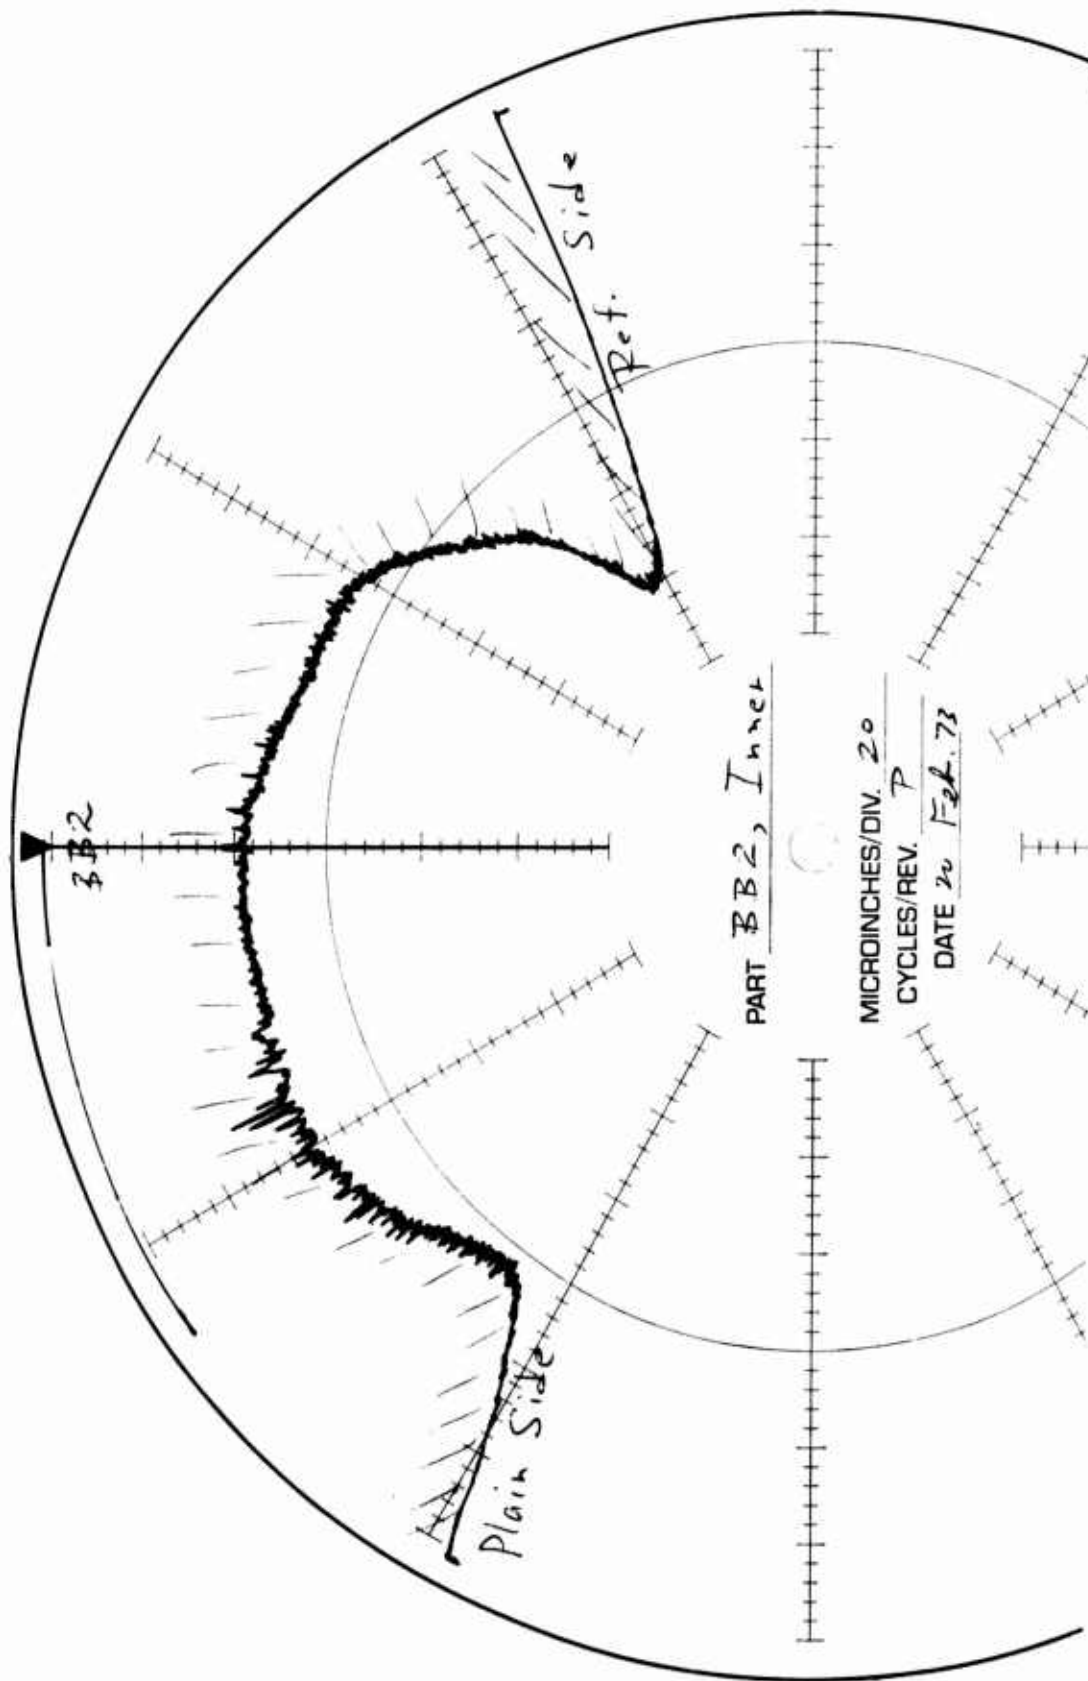
Figure 116. BB-2 Cross-Groove Profile at Zero Test Hours.

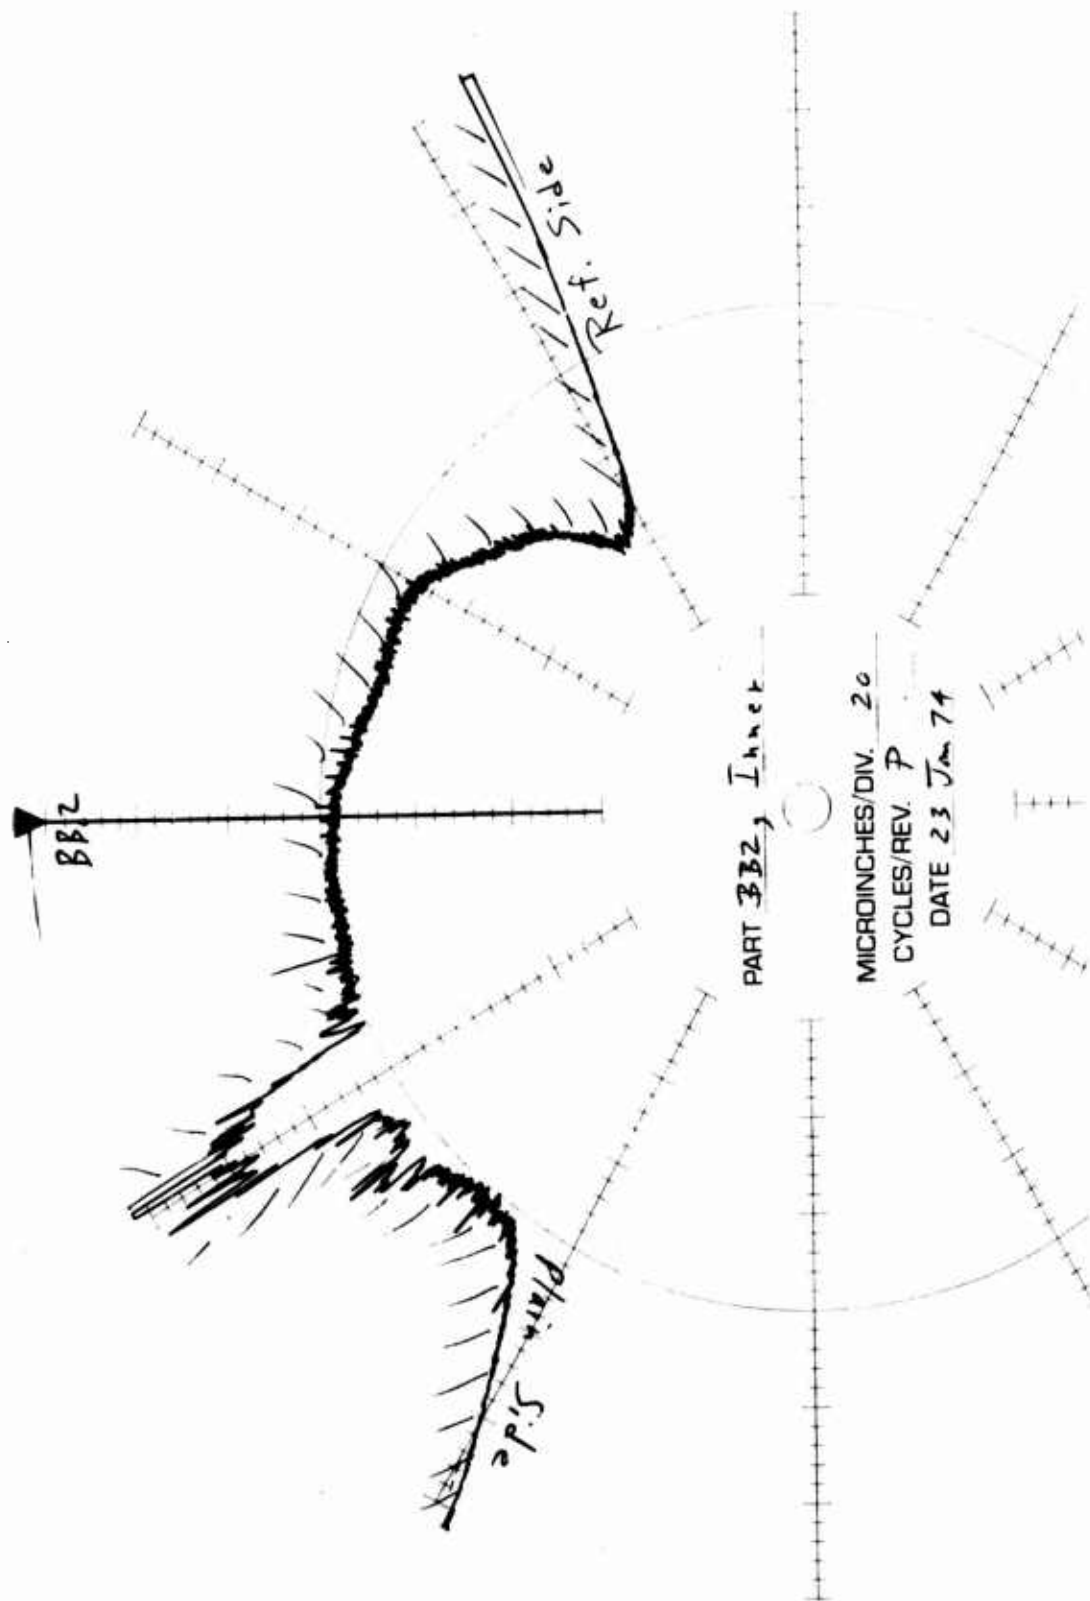
Figure 117. BB-2 Cross-Groove Profile at 166 Test Hours.

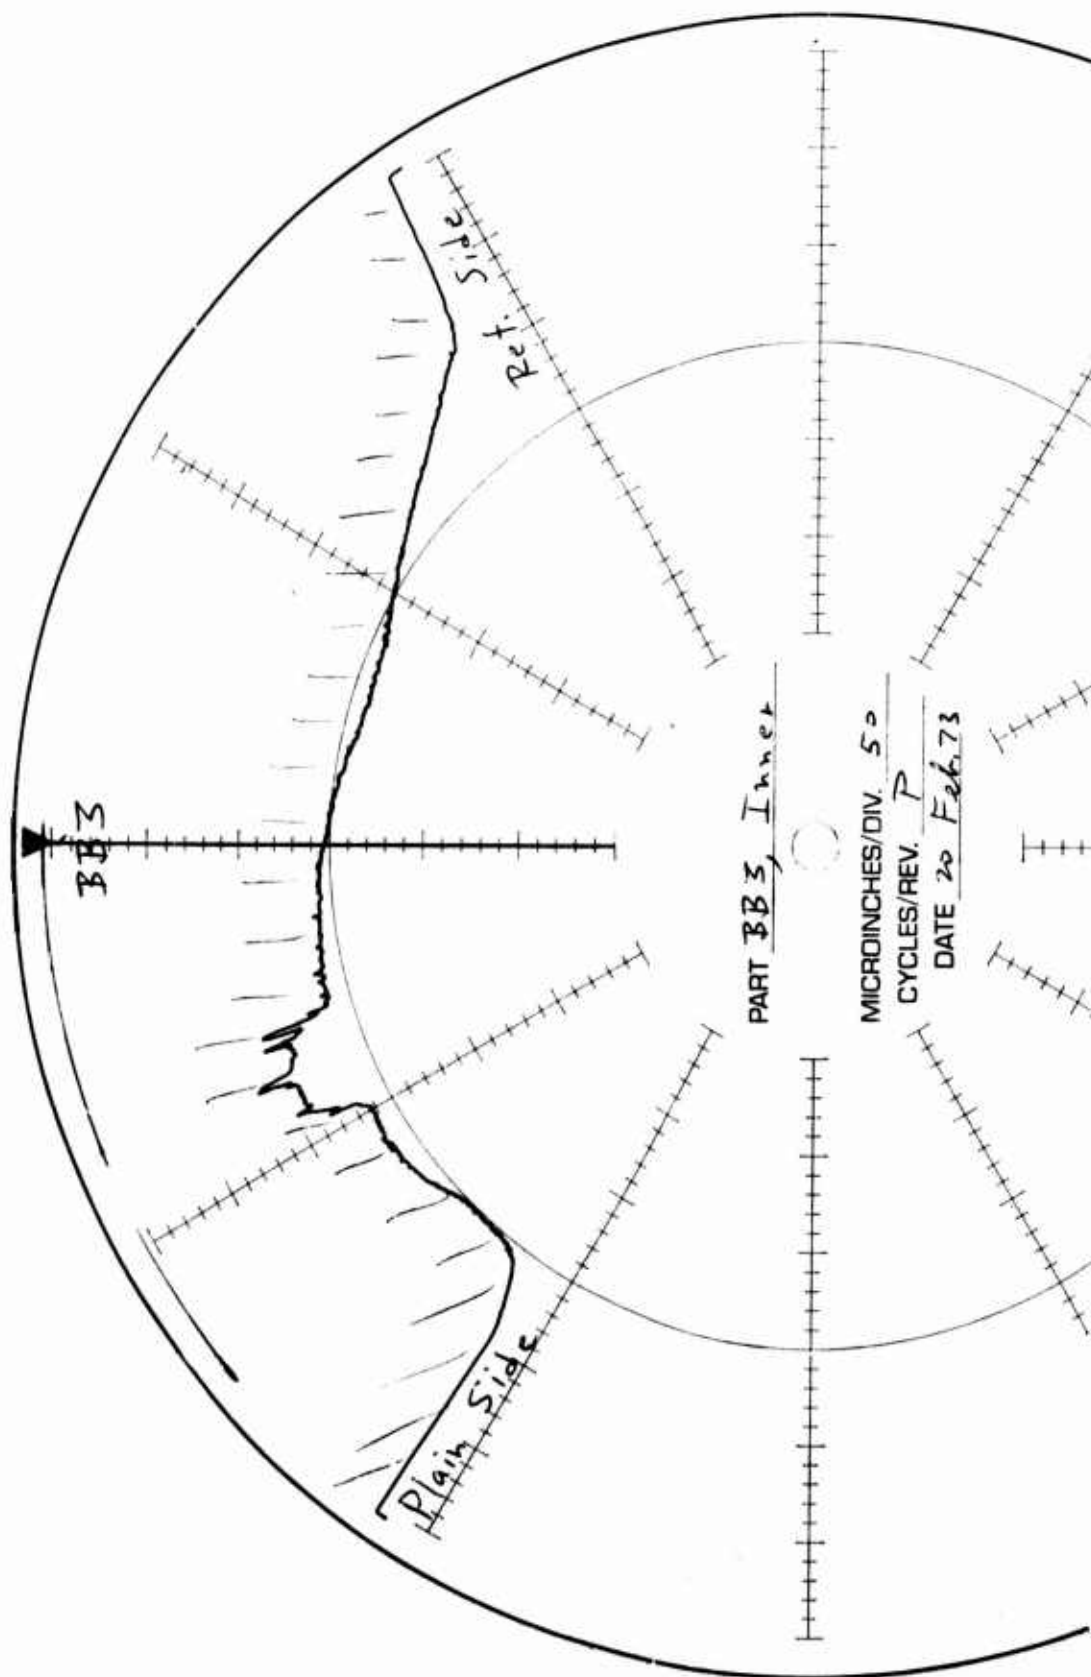
Figure 118. BB-3 Cross-Groove Profile at Zero Test Hours.

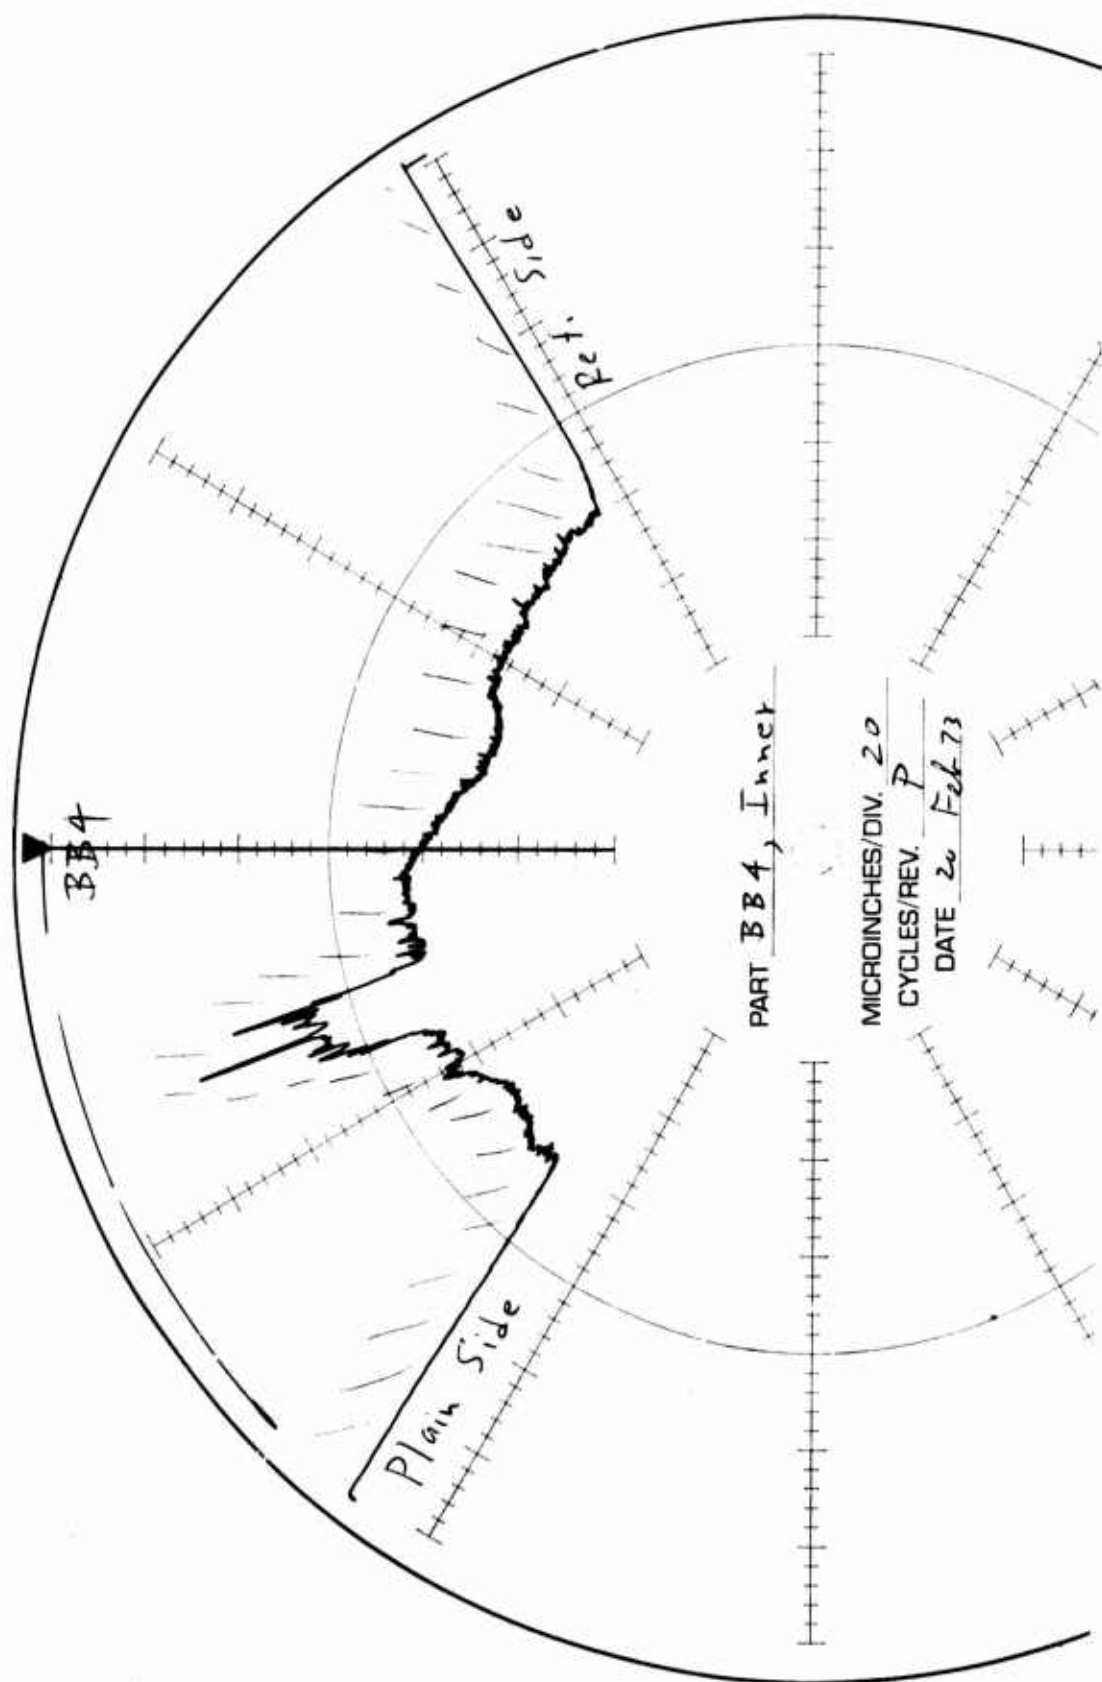
Figure 120. BB-4 Cross-Groove Profile at Zero Test Hours.

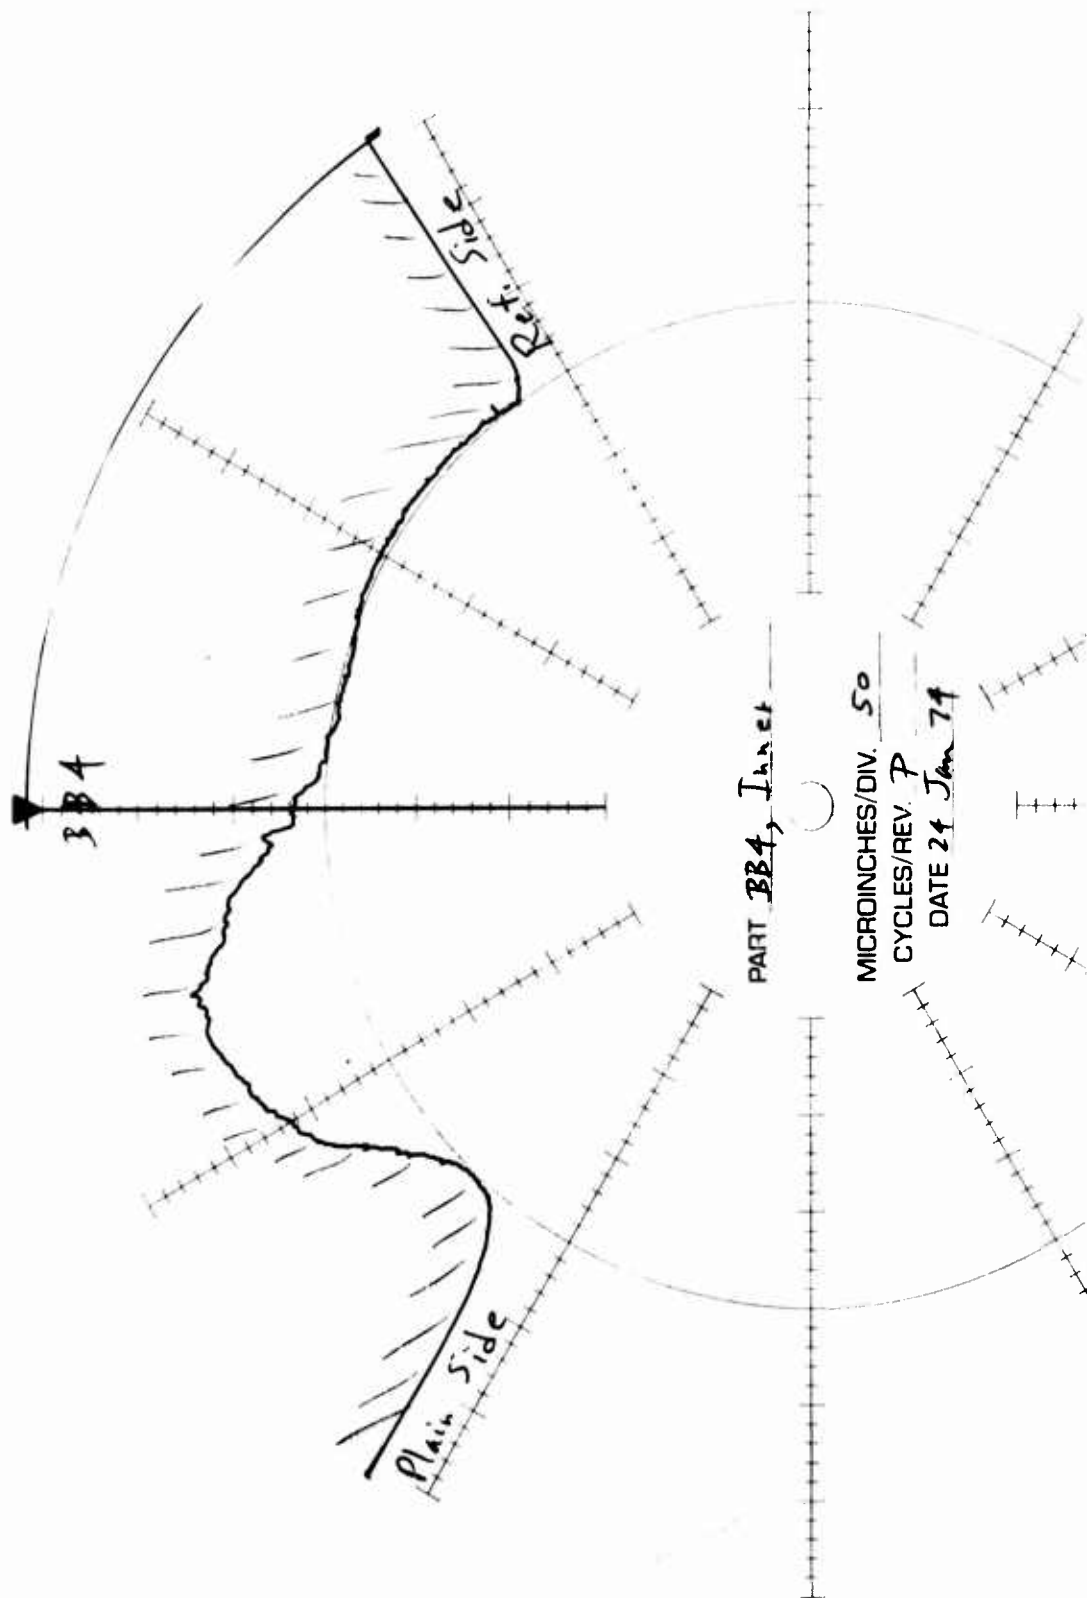
Figure 121. BB-4 Cross-Groove Profile at 166 Test Hours.
